Corridor Recommendations

Detailed Map Books

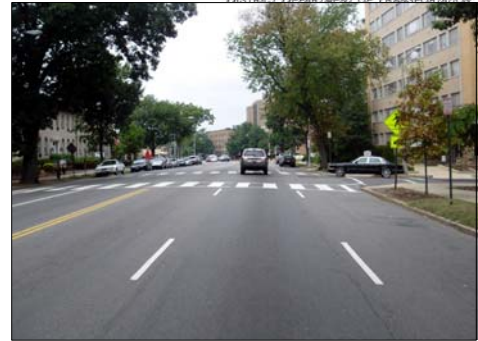
Uncontrolled marked crossing on Wisconsin Avenue at Lowell St NW

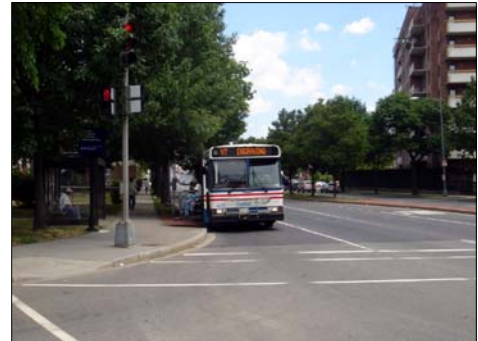
Near-side bus stop on M Street SW
